8D Corrective Action Report

Device: FSD200B

PQA Number: 2007360025

Final 8D

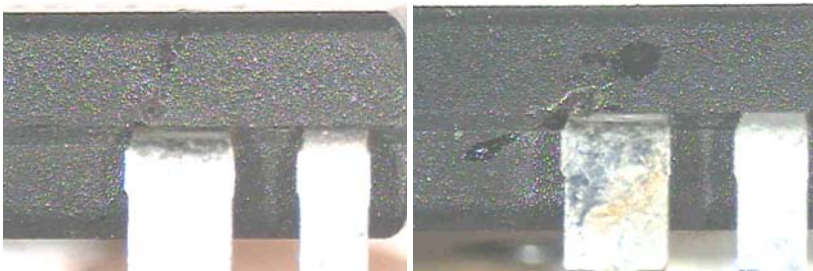
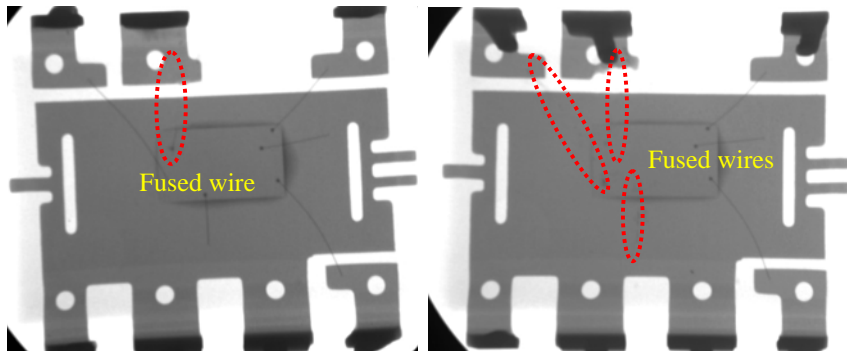
External Visual: 18pcs out of 21pcs showed PKG burnt mark and fused wire at pin#7, and the rest 3pcs(SN#10,12,17) were normal in visual and x-ray inspection.

1. The view of PKG outside and inside. (18pcs showed similar PKG burnt and fused wire at pin#7)

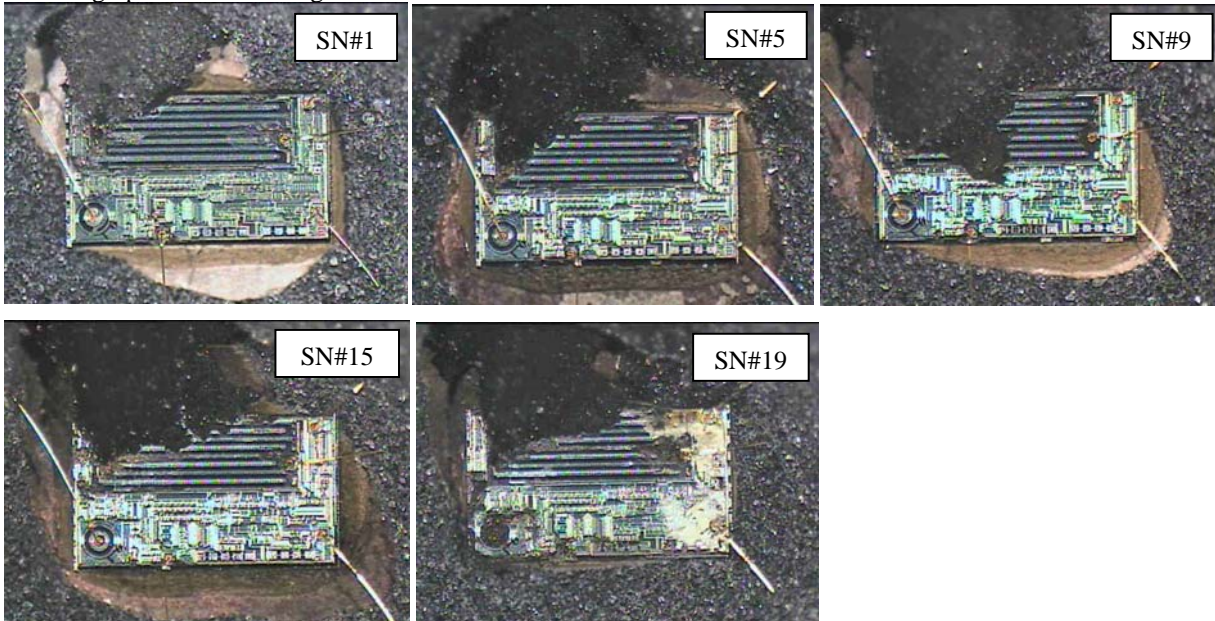
3. Photographs after removing EMC.

Some(1,5,9,15,19) of the failed samples were performed chemical de-capsulation using fuming nitric acid due to the same failure mode and then inspected with microscope. The samples showed huge damaged mark on the Power IC. FKS(Fairchild Korea Semiconductor Ltd.) could not define exact root cause due to severe burnt from this FA. Thus, FKS would like to present some possible causes to better understand this failure in customer side.
