InPower Semiconductor Co., Ltd

FAILURE ANALYSIS REPORT

Customer: 晶门 (营格)
Evaluation Item: FTA06N65
FA No.: CP-12084 FA-12084
Requested by: Sales/IPS
Completed by: David
Completed Date: 11/2/2012

Customer part number:
IPS part number: FTA06N65
Date Code(s): YKE2/YLB2/YLG2/YLF2
Package Type: T0-220F
Quantity Received: 8 pcs
Date Received: 10/25/2012

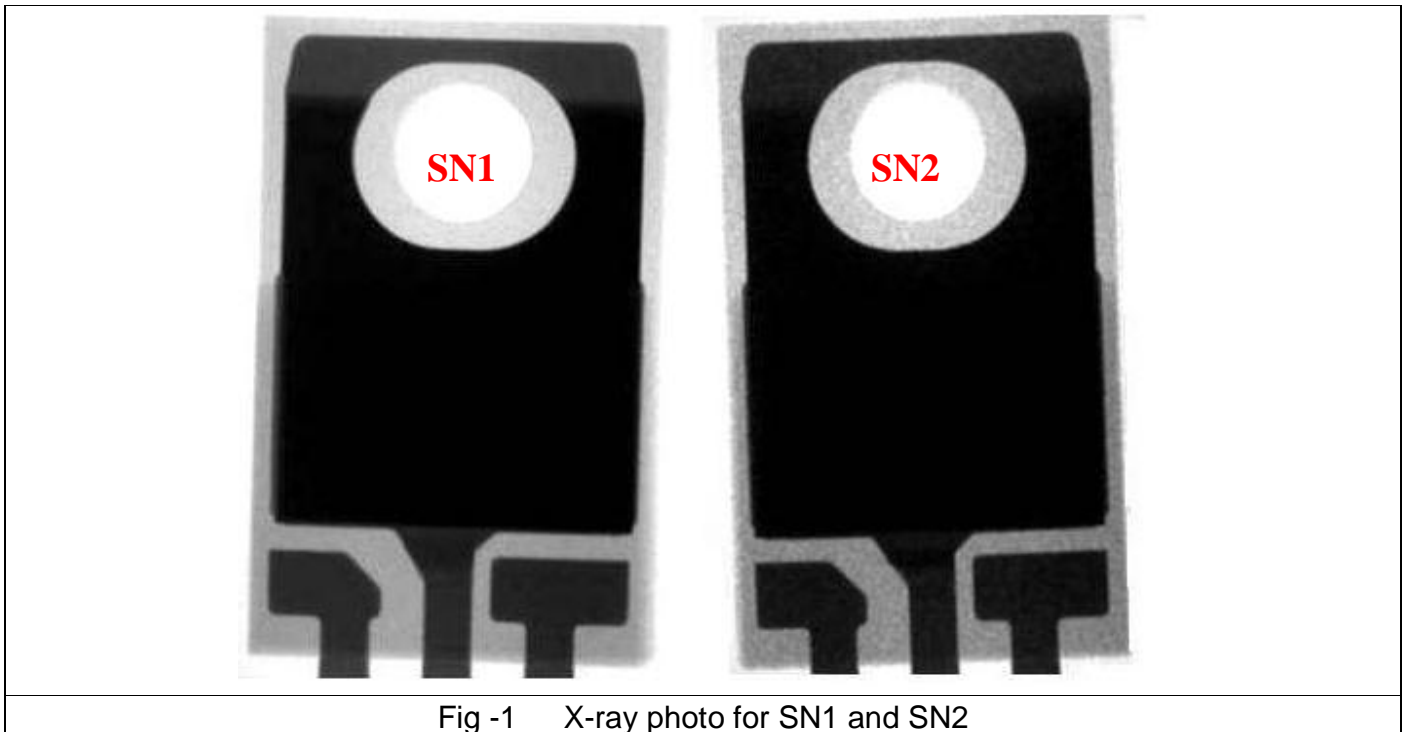
Fig -1 X-ray photo for SN1 and SN2

There's no assembly defect on the TO-220F packaged devices.

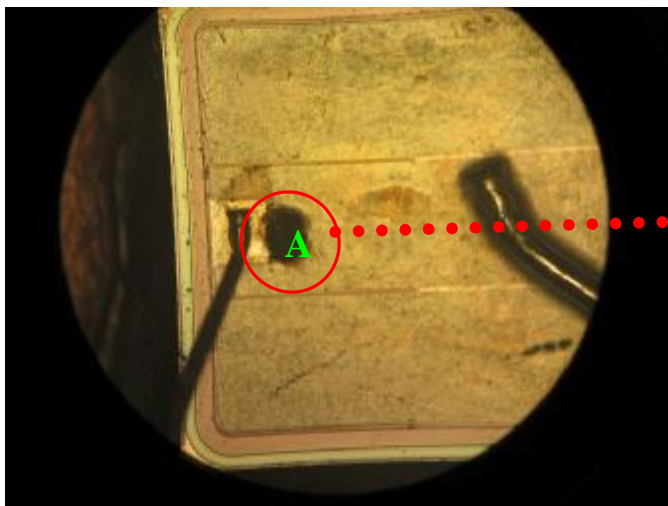
Fig-4 De-capsulation Photo for SN1

1. The devices are shorted on gate and drain and source terminals which are failed in our FT test.
2. There's no assembly defect on this TO-220F packaged devices, as checked by X-ray machine and shown in Figure 1.
3. De-capsulation on SN1 and SN2 exhibit the burnt sites happened on the Gate and Source area. Electrical over stress (EOS), especially over Gate Voltage applied to MOSFET is the likely root cause. Special cares on the spike voltage is necessary to keep MOSFET from over -voltage failures.

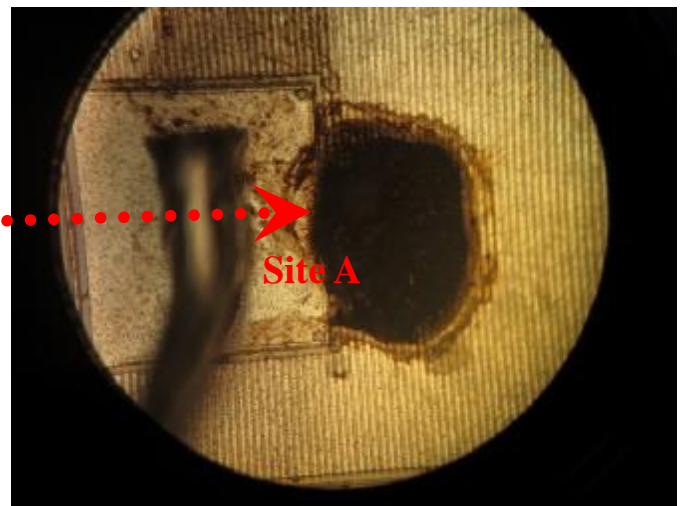
Fig-5 Closer view of Failure site A in SN1

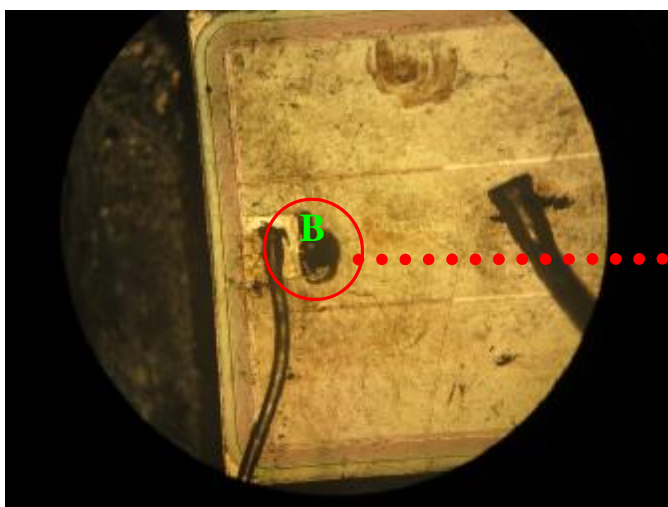
Fig-6 De-capsulation Photo for SN2

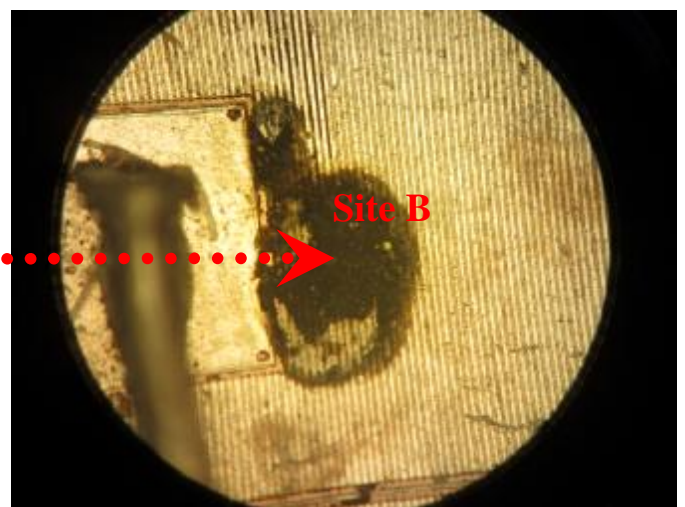
Fig-7 Closer view of Failure site B in SN2
